# **HYDROGEOMORPHIC EVALUATION OF ECOSYSTEM RESTORATION AND MANAGEMENT OPTIONS FOR MONTE VISTA NATIONAL WILDLIFE REFUGE**

**Greenbrier Wetland Services  
Report 13-02**

**February 2013**

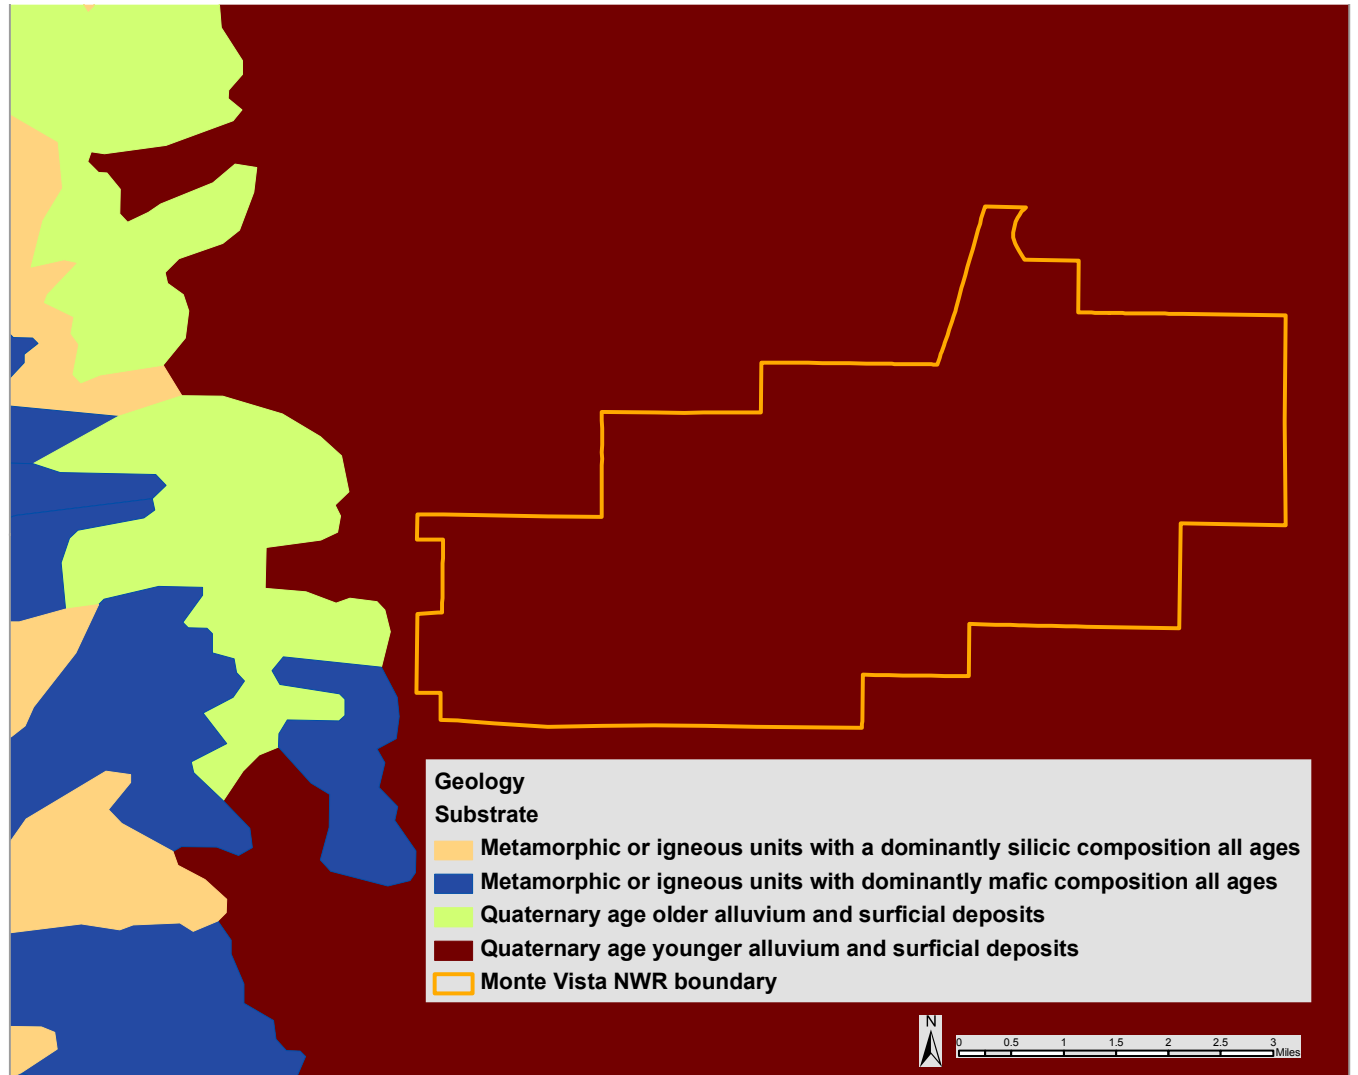
Figure 5. Surficial geology of the Monte Vista National Wildlife Refuge region (from USDA, Natural Resource Conservation Service, DataGateway site).

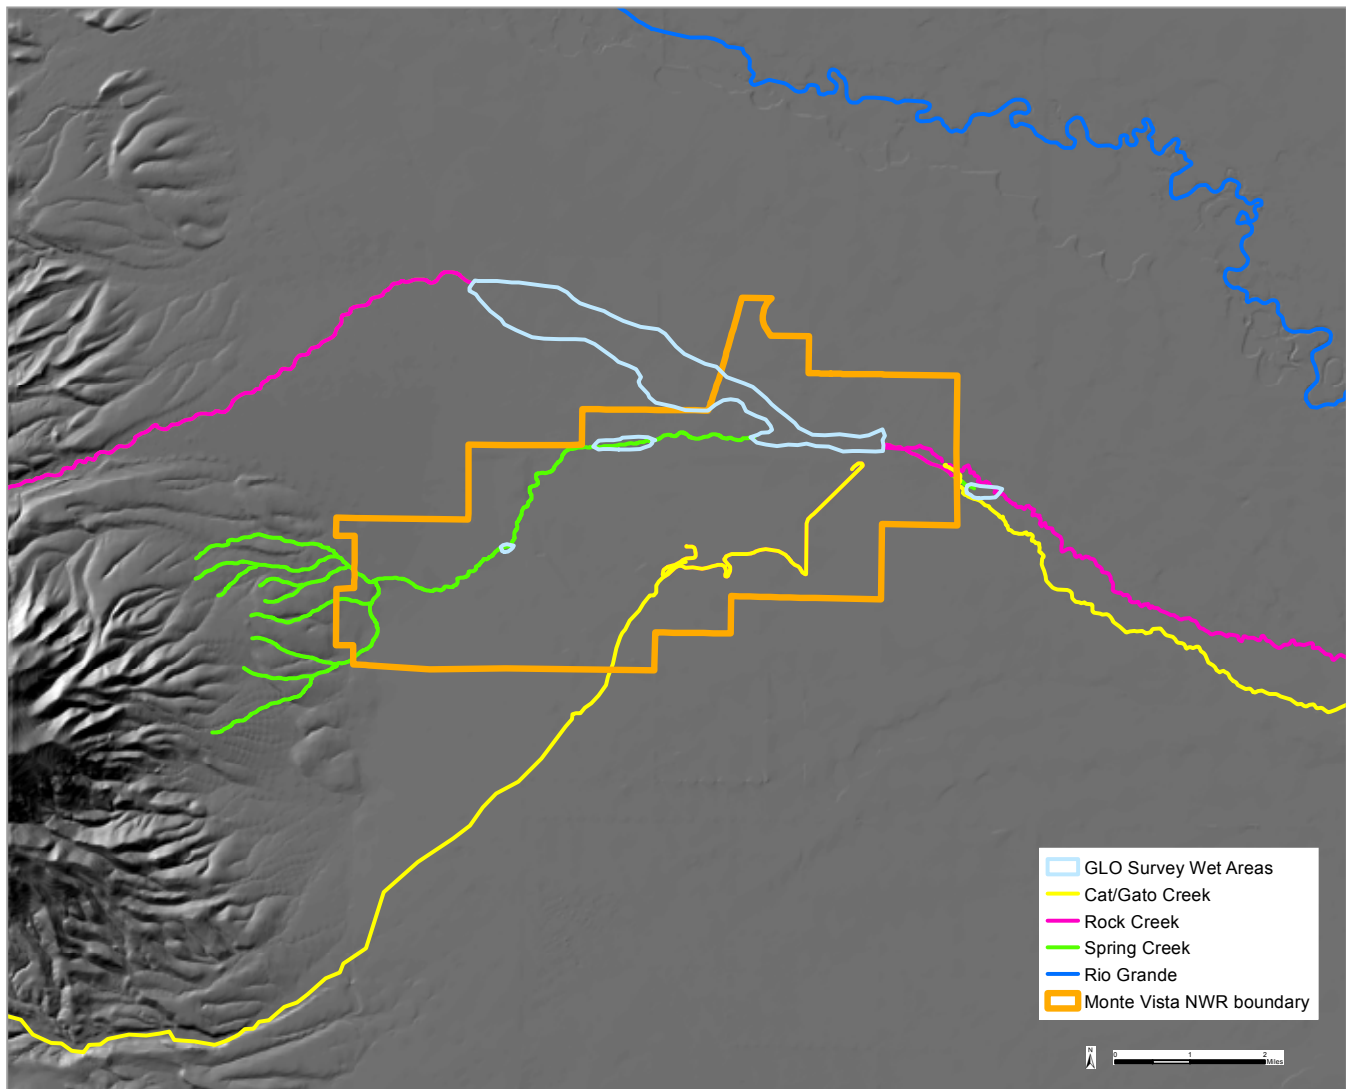
Figure 6. Location of major creeks flowing into and through Monte Vista National Wildlife Refuge.

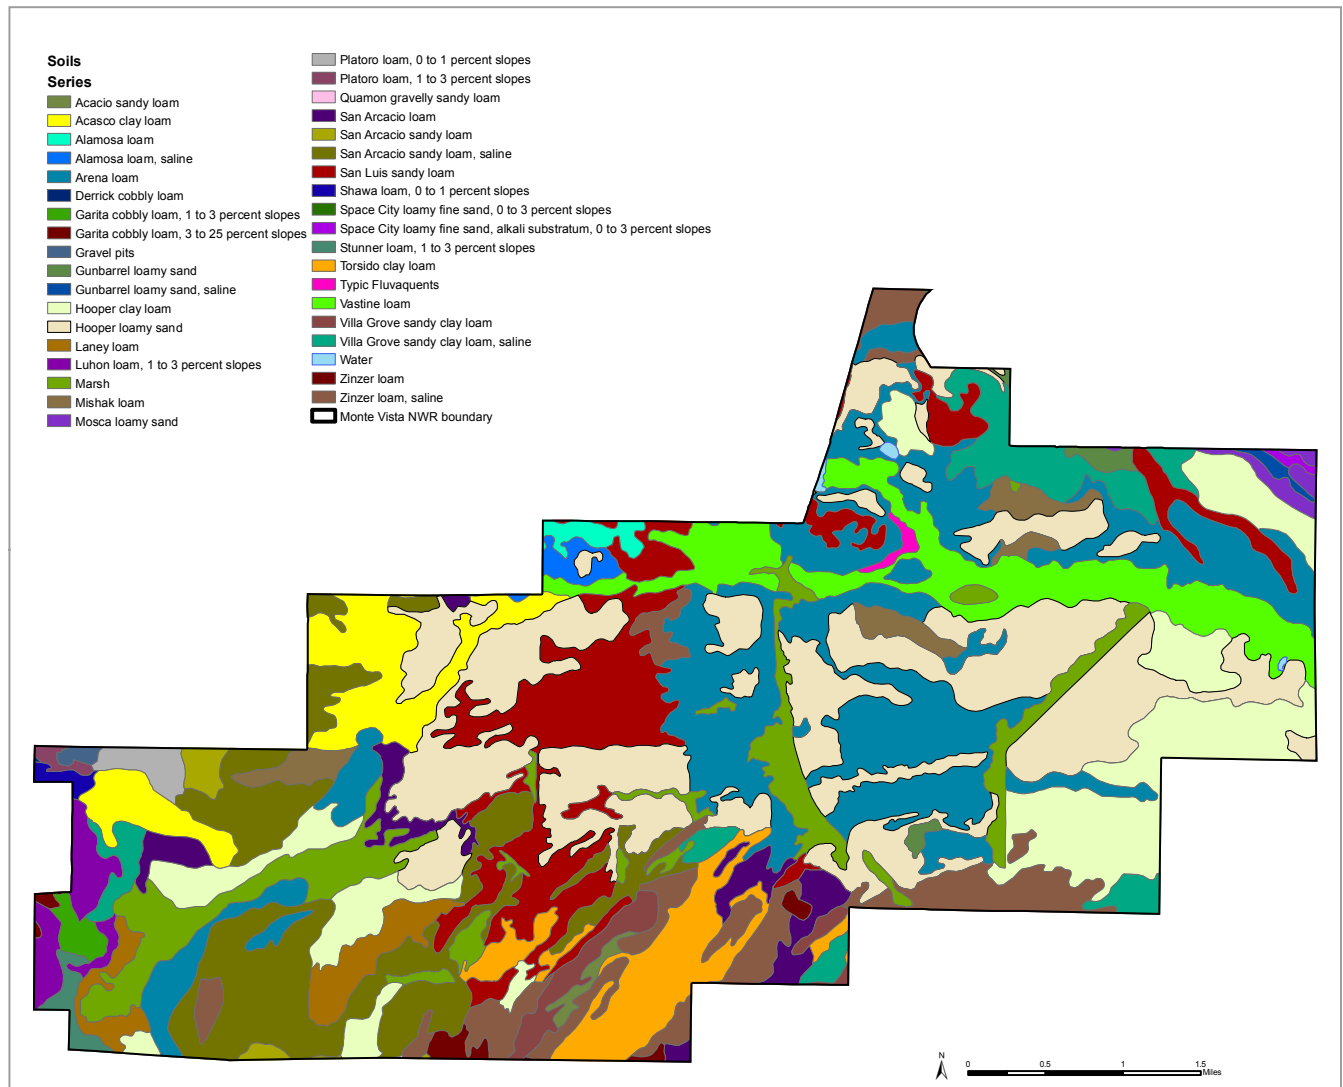
Figure 7. Soils on Monte Vista National Wildlife Refuge (from USDA SSURGO) datasets).

1800s to early-1900s. The former existence of a creek at this location on Monte Vista NWR is corroborated in part by the presence of Acasco and Torsido clay loam “wetland type” soils in this area (SCS 1980, Fig. 7). Given the sporadic documentation of this creek in various reports, maps, surveys, and aerial photographs, it seems reasonable to assume that Cat Creek was an intermittent stream that contained surface water flow during peak seasonal runoff periods and during wetter years. This “intermittent” hypothesis might account for the disappearance of the creek in the southern portion of the refuge and its re-emergence south of Rock Creek to the east. Further, its absence from the GLO and other documents in the Monte Vista NWR area may reflect drought or dry seasons when the GLO survey occurred.

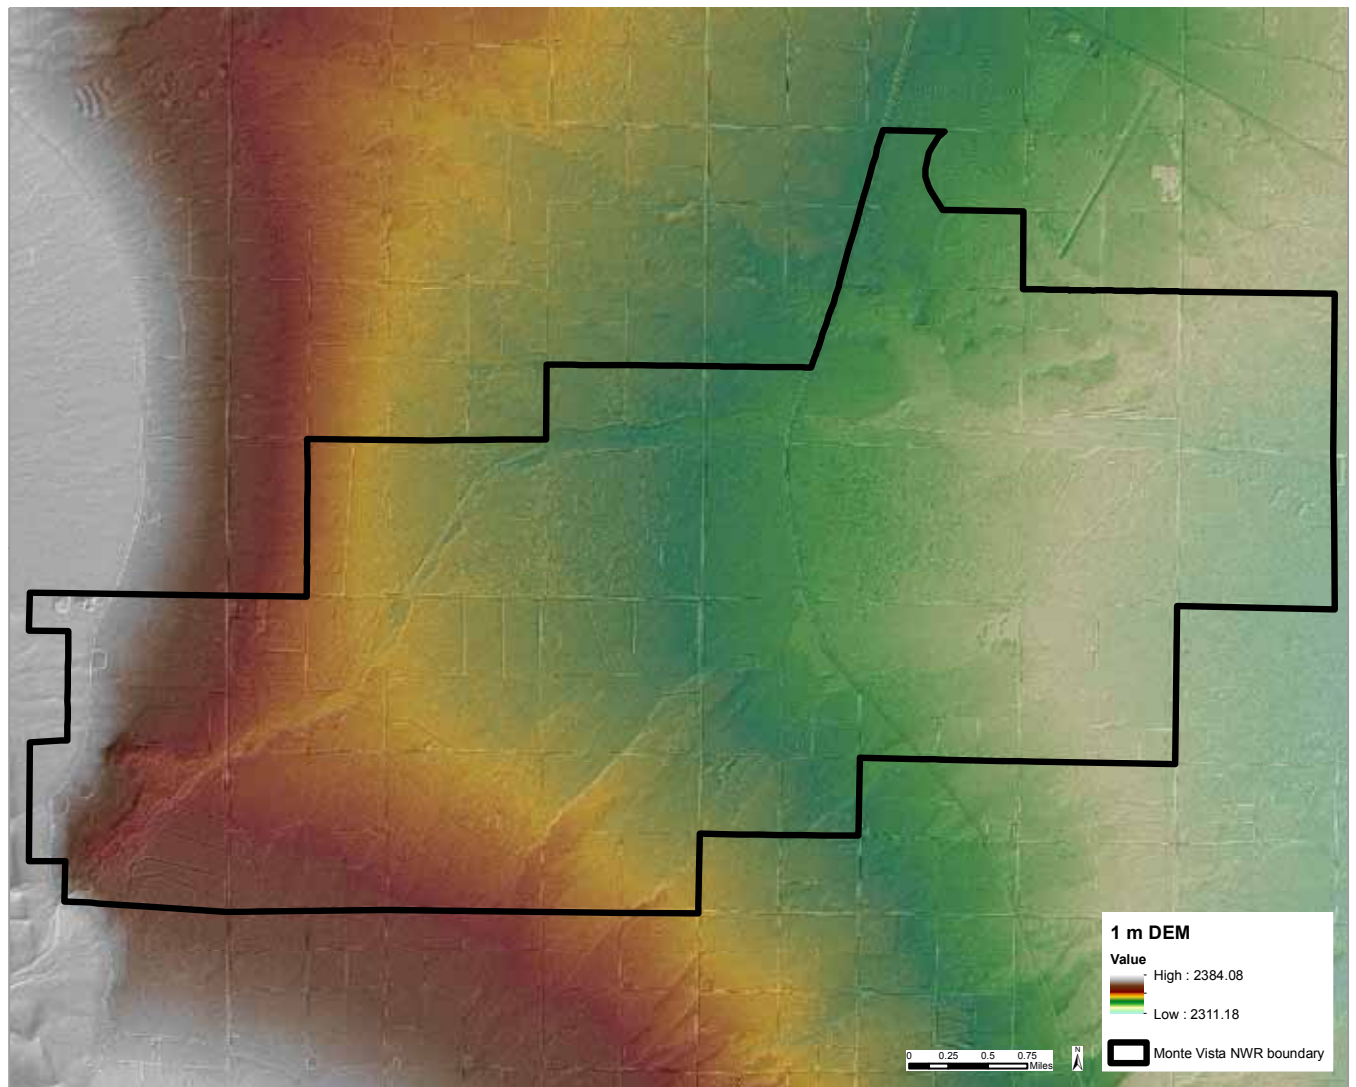
Figure 8. One meter DEM LiDAR elevations for Monte Vista National Wildlife Refuge.

refuge slope from 7,732 feet on the west boundary to 7,586 feet on the east boundary (Fig. 8). The LiDAR-DEM maps clearly identify the San Juan Mountain foothill area on the refuge (shown in red to yellow shading) that sharply transitions onto the large alluvial fan surface that covers the remainder of the refuge. The former creek and channel areas of Spring, Rock, and Cat Creeks also are distinguishable as are more subtle topographic features such as relict scour and deposition surfaces related to their historic fluvial dynamics (Fig. 9). Land depressions, indicated by marked changes in topography within the larger alluvial fan, suggest possible wetland depressions that historically occurred along the creek drainage corridors, especially in the confluence area of Spring and Rock creeks. The General Land Office (GLO) maps prepared from 1875 to 1880 also show

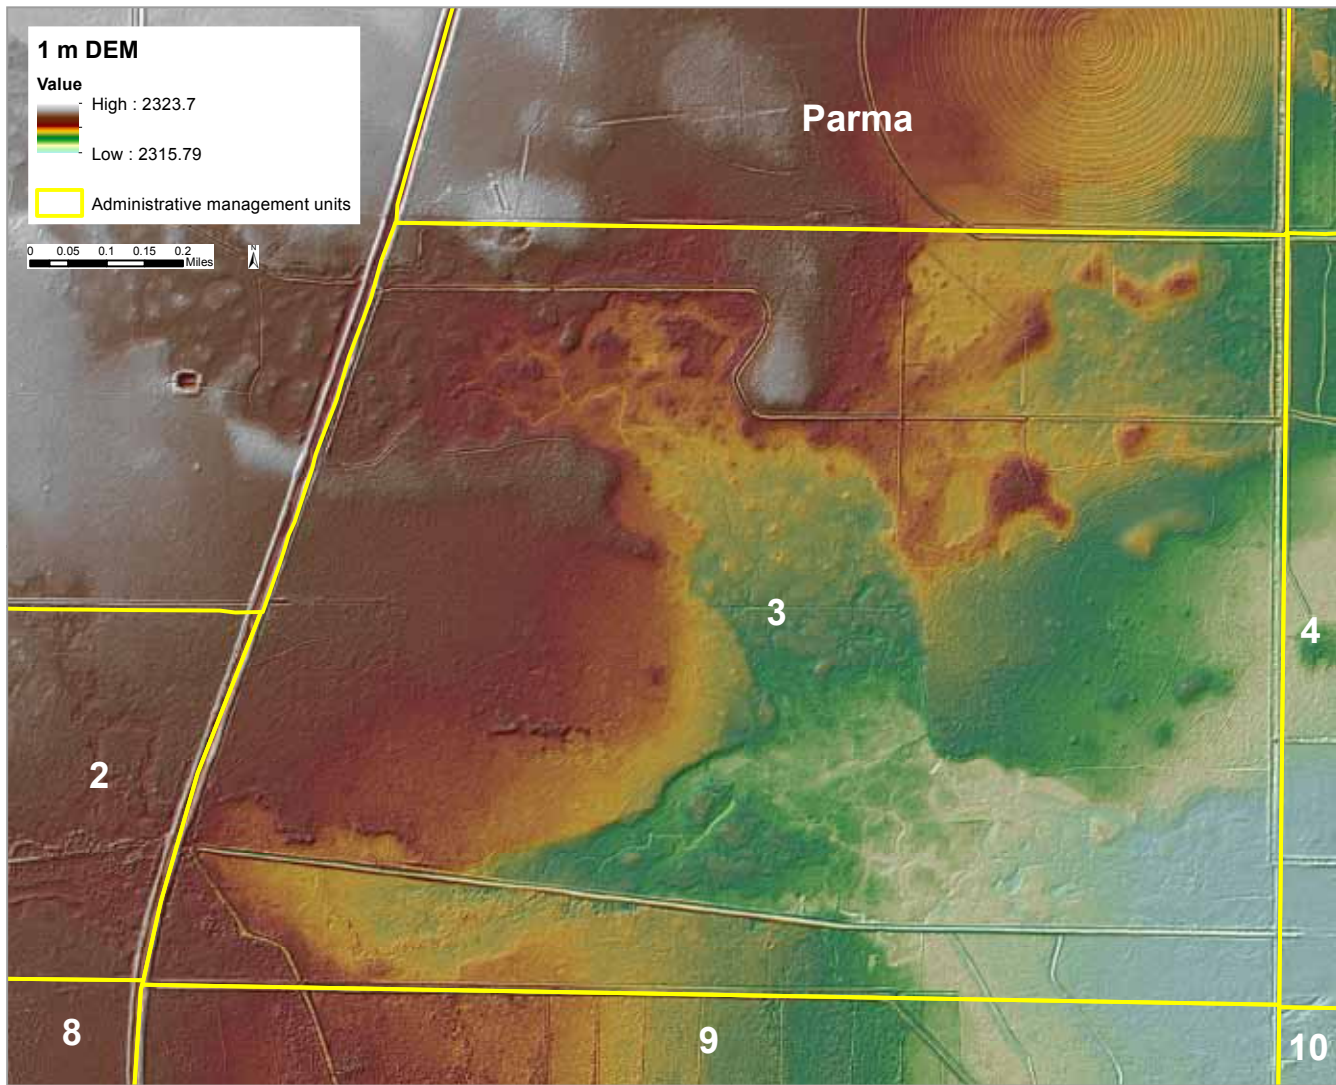
Figure 9. One meter DEM LiDAR elevations of Unit 3 in Monte Vista NWR.

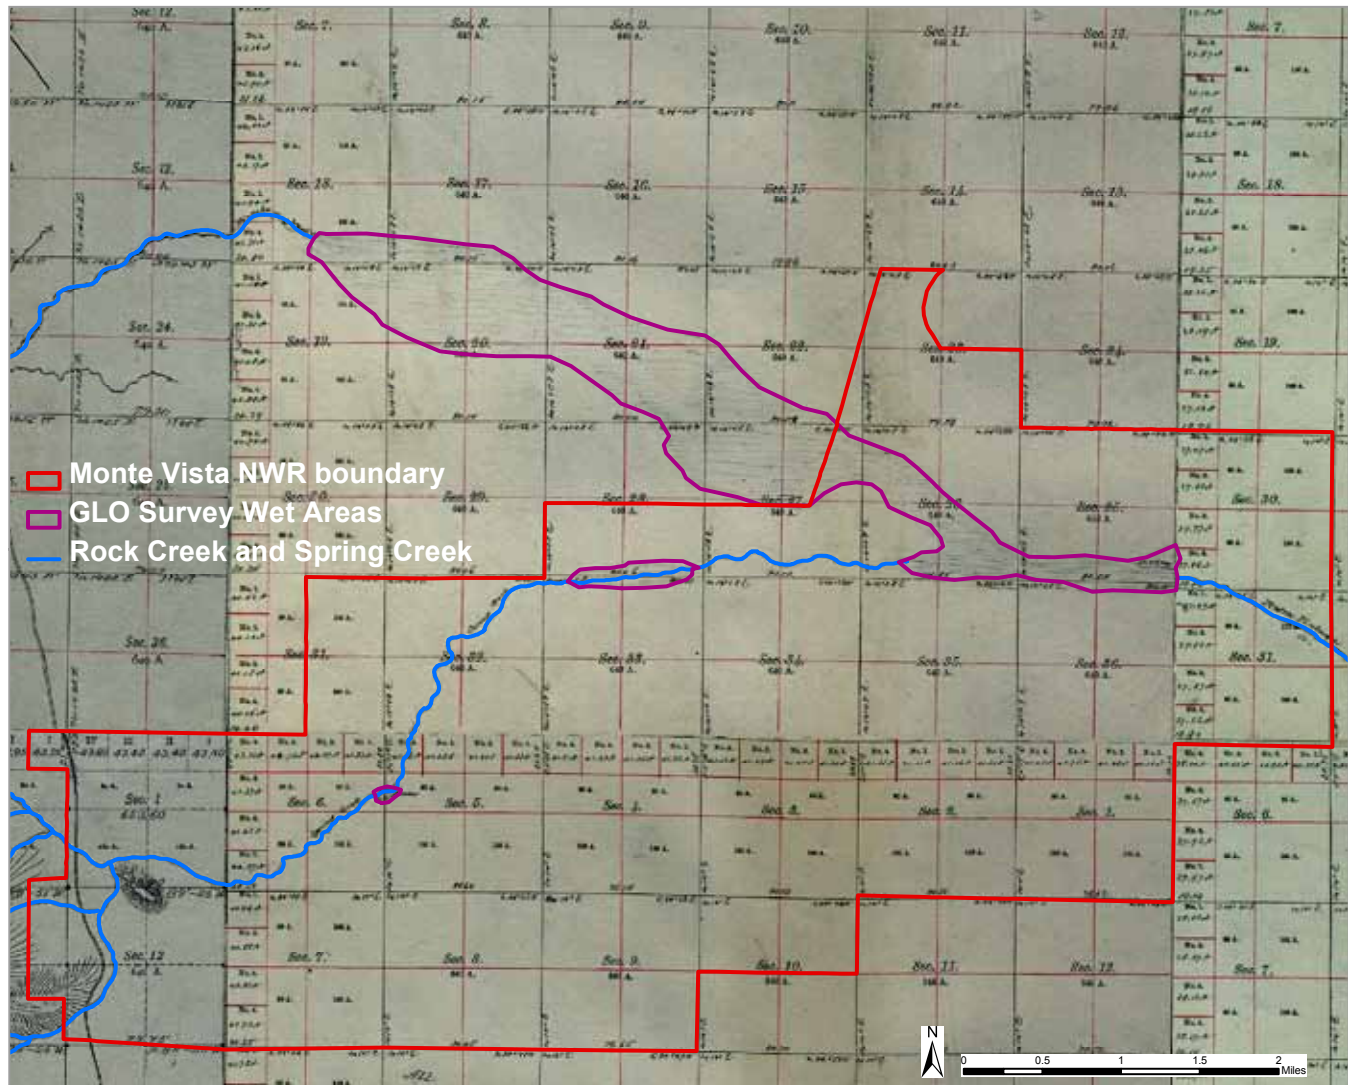
Figure 10. General Land Office map of the Monte Vista National Wildlife Refuge region.

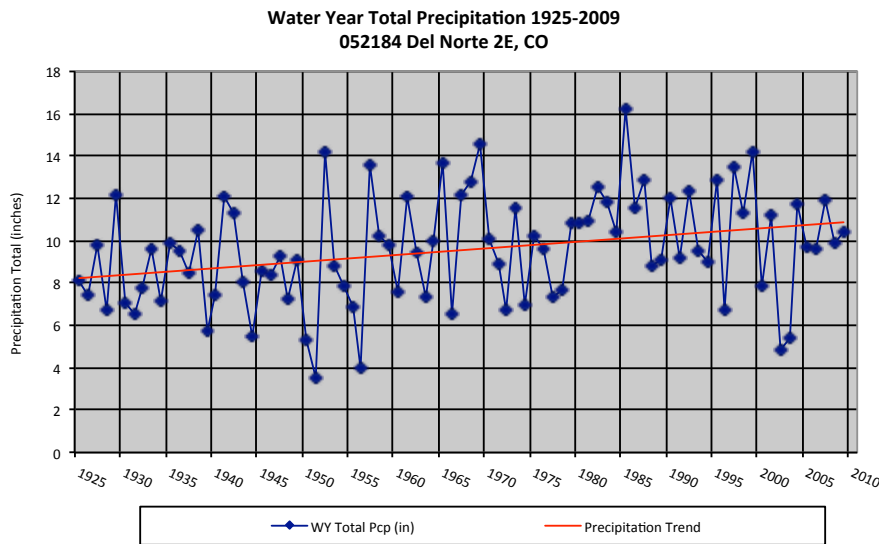
Figure 11. Total water year precipitation (inches) for Del Norte, CO, 1925-2009 (from Striffler 2012).

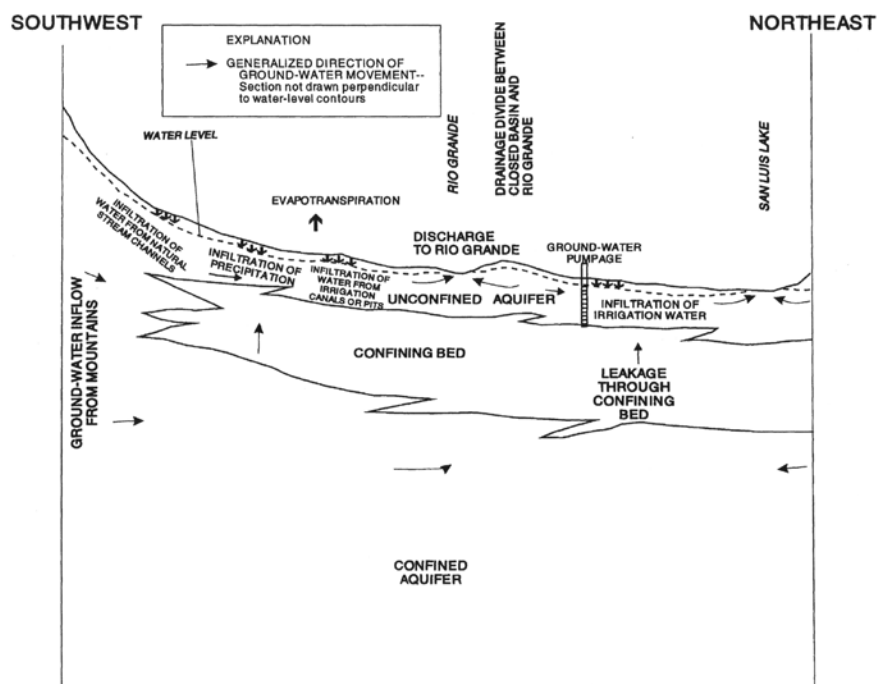
Figure 13. Schematic cross-section of groundwater movement in relation to the unconfined and confined aquifers in the San Luis Valley (modified from Hanna and Harmon 1989).

The confined aquifer occurs below the unconfined alluvial aquifer and consists of an active and passive zone (Fig. 13). At the periphery of the SLV, the unconfined and active confined aquifers are directly connected hydraulically. Recharge to the active confined aquifer takes place, in part, through the unconfined aquifer at these locations. The active confined aquifer is up to 4,000 feet below the land surface. Recharge to the confined aquifer occurs along the margins of the SLV from infiltration of precipitation, infiltration of surface water, and inflow of groundwater from the adjacent San Juan Mountains. Discharge from the confined aquifer occurs as groundwater flow to the south and upward leakage through the confining bed. A generalized schematic of hydrologic flow in the San Luis Valley (including current modifications and management) is provided in Fig. 14.

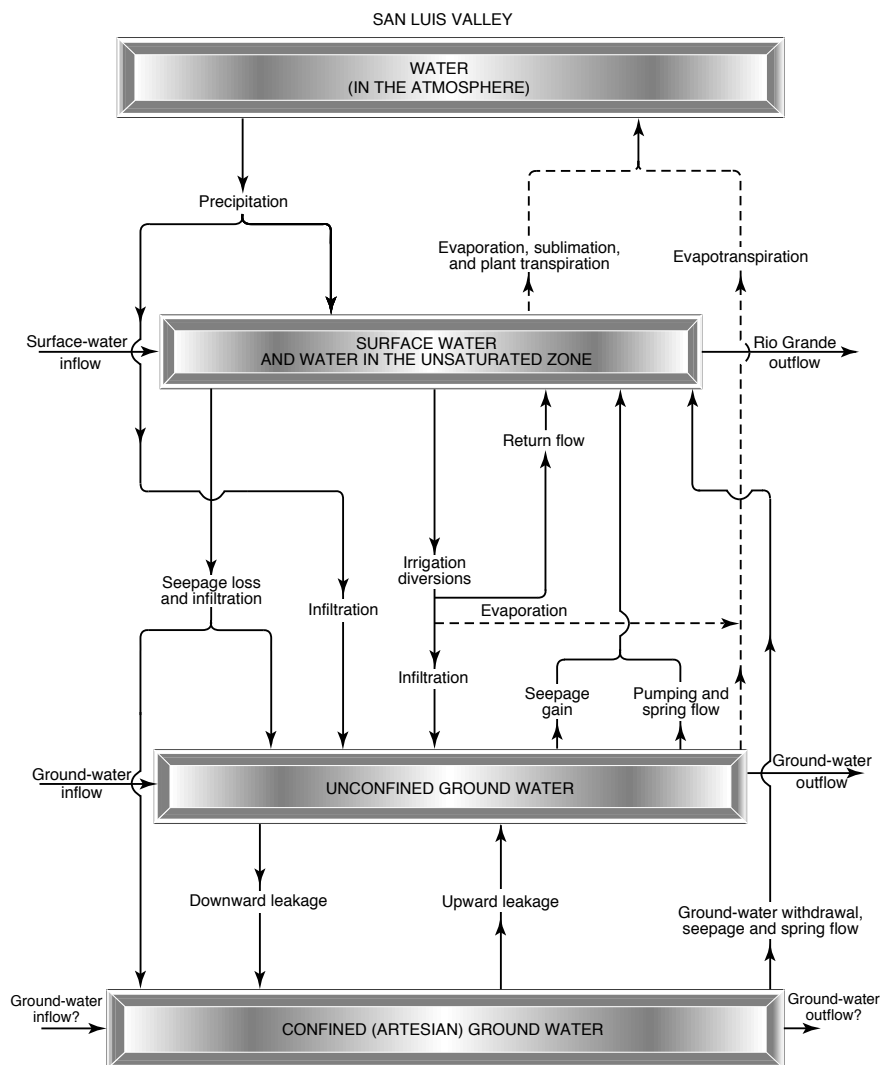
Figure 14. Generalized hydrological flow diagram of the San Luis Valley (modified from U.S. Bureau of Reclamation 1995 and Wilkins 1998).

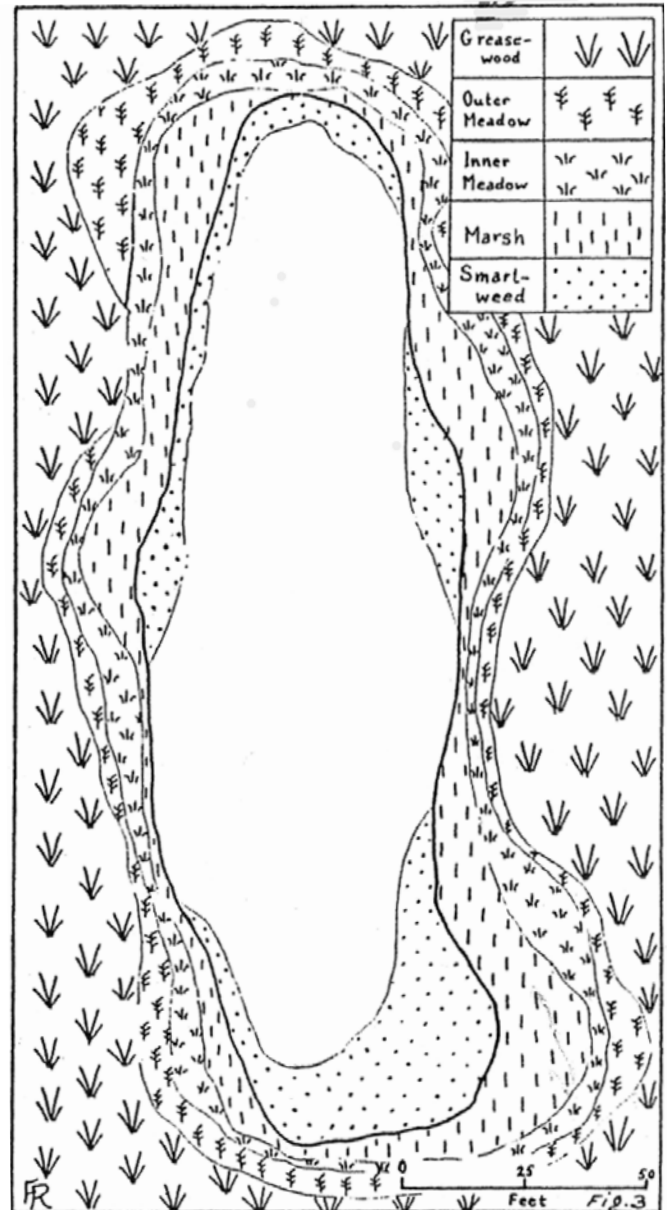
Figure 15. Vegetation associations around a typical semipermanently flooded wetland in the San Luis Valley (from Ramaley 1942).

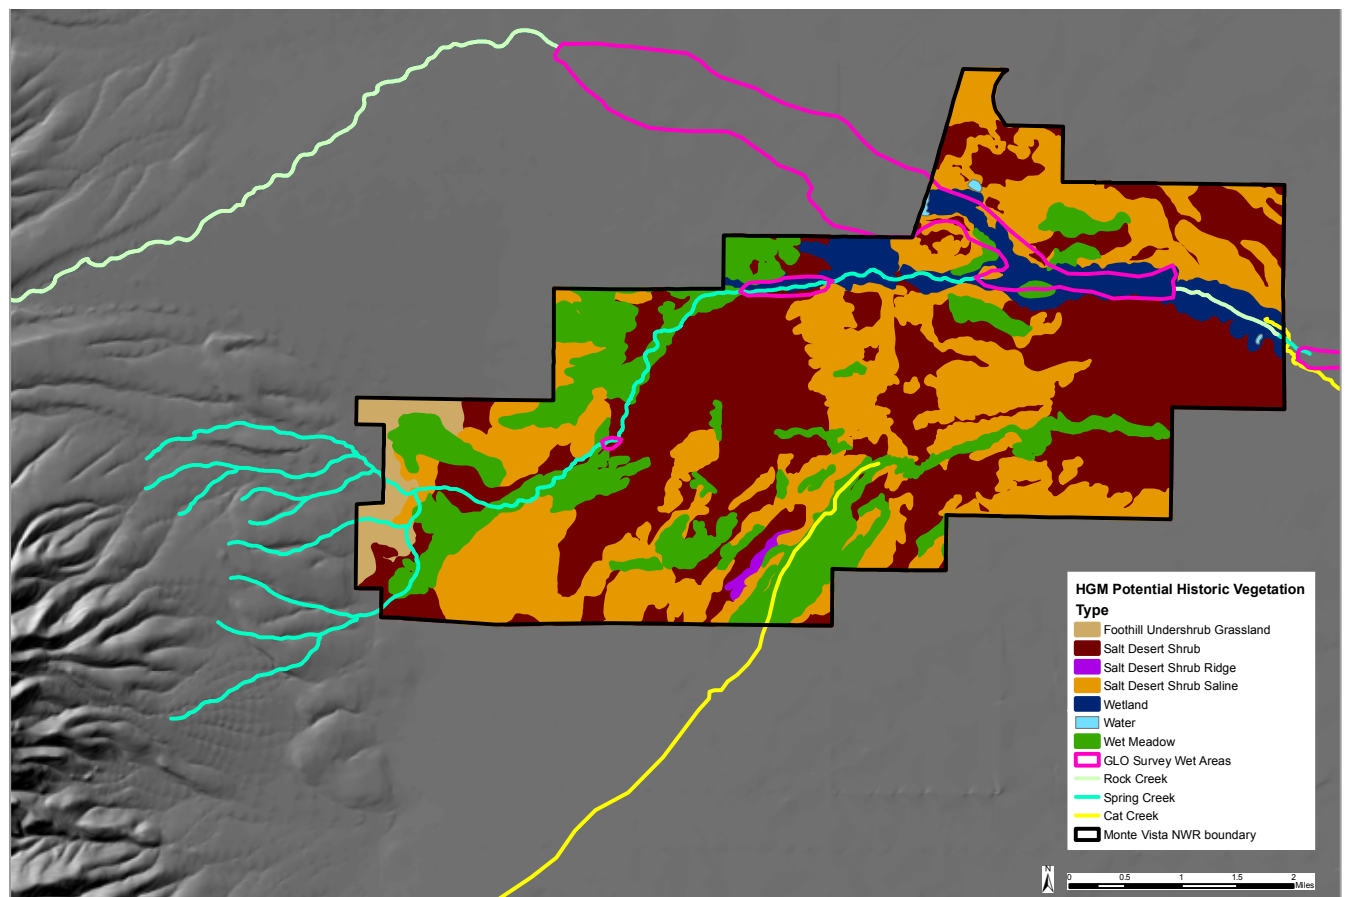
Figure 16. Potential historical vegetation community distribution on Monte Vista National Wildlife Refuge (mapped using HGM attribute relationships in Table 5).

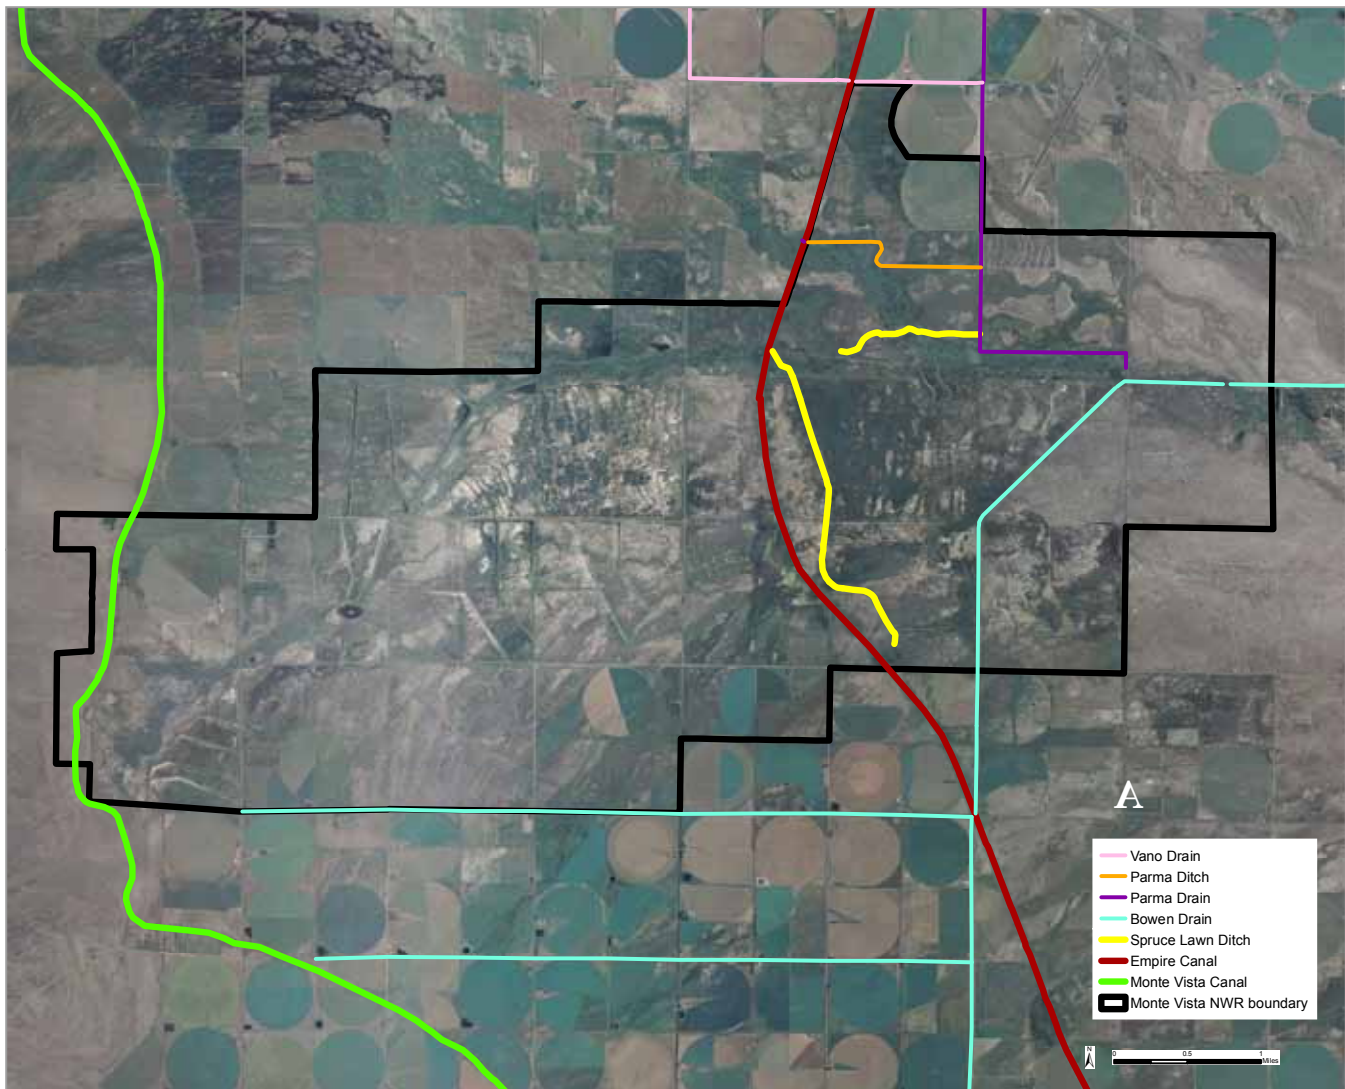
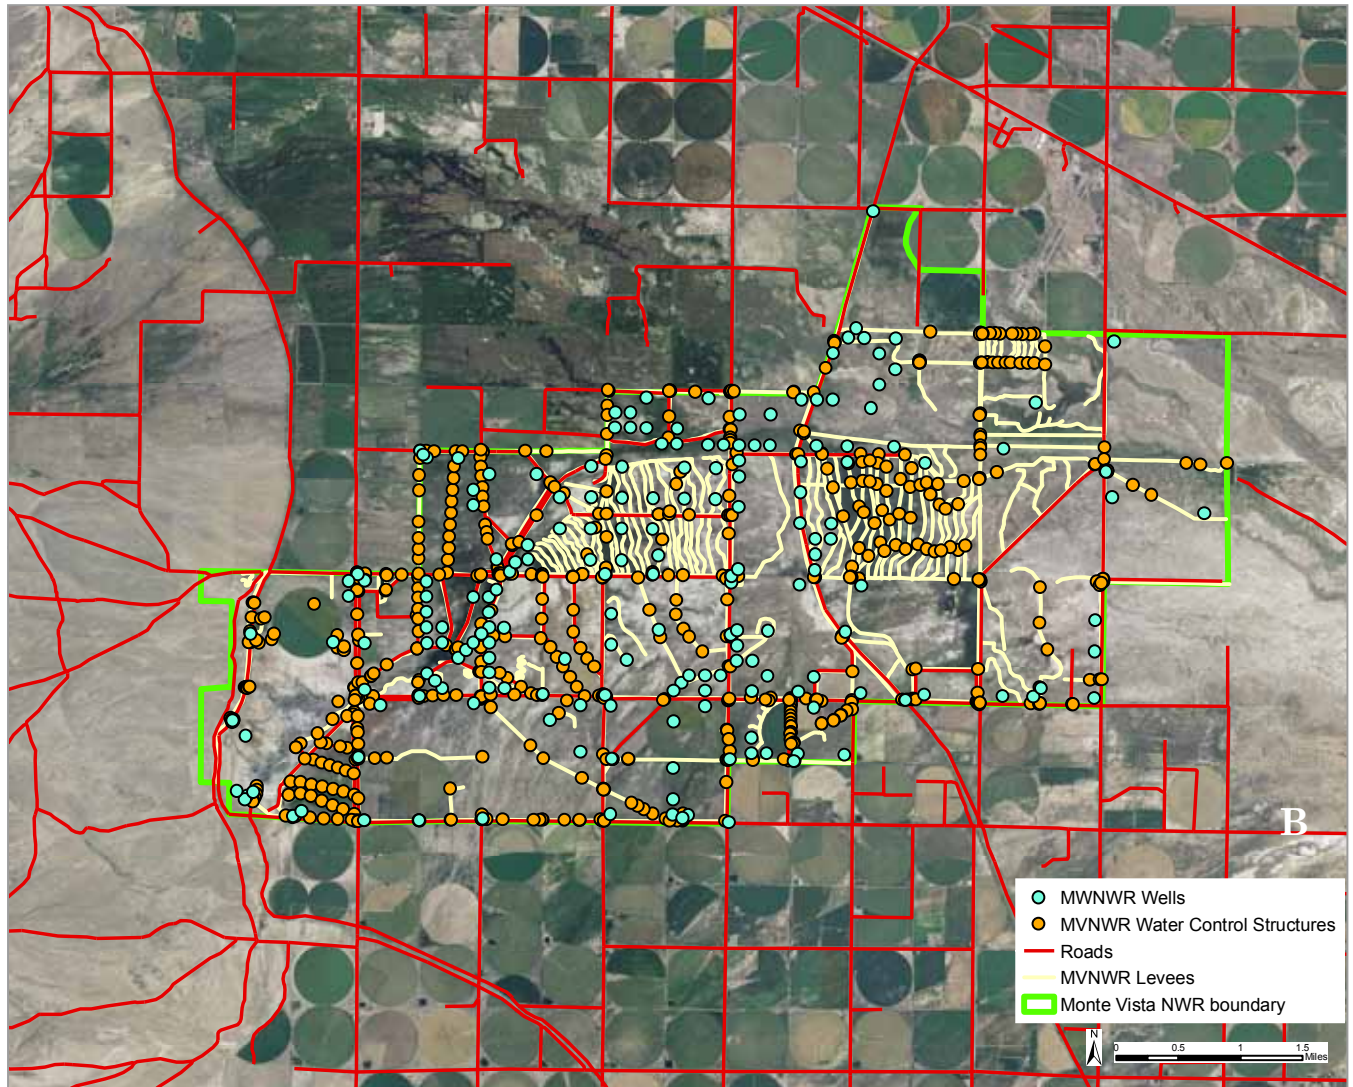
Figure 19. Location of: a) major ditches and drains and b) wells, water-control structures, levees, and roads on Monte Vista

National Wildlife Refuge.

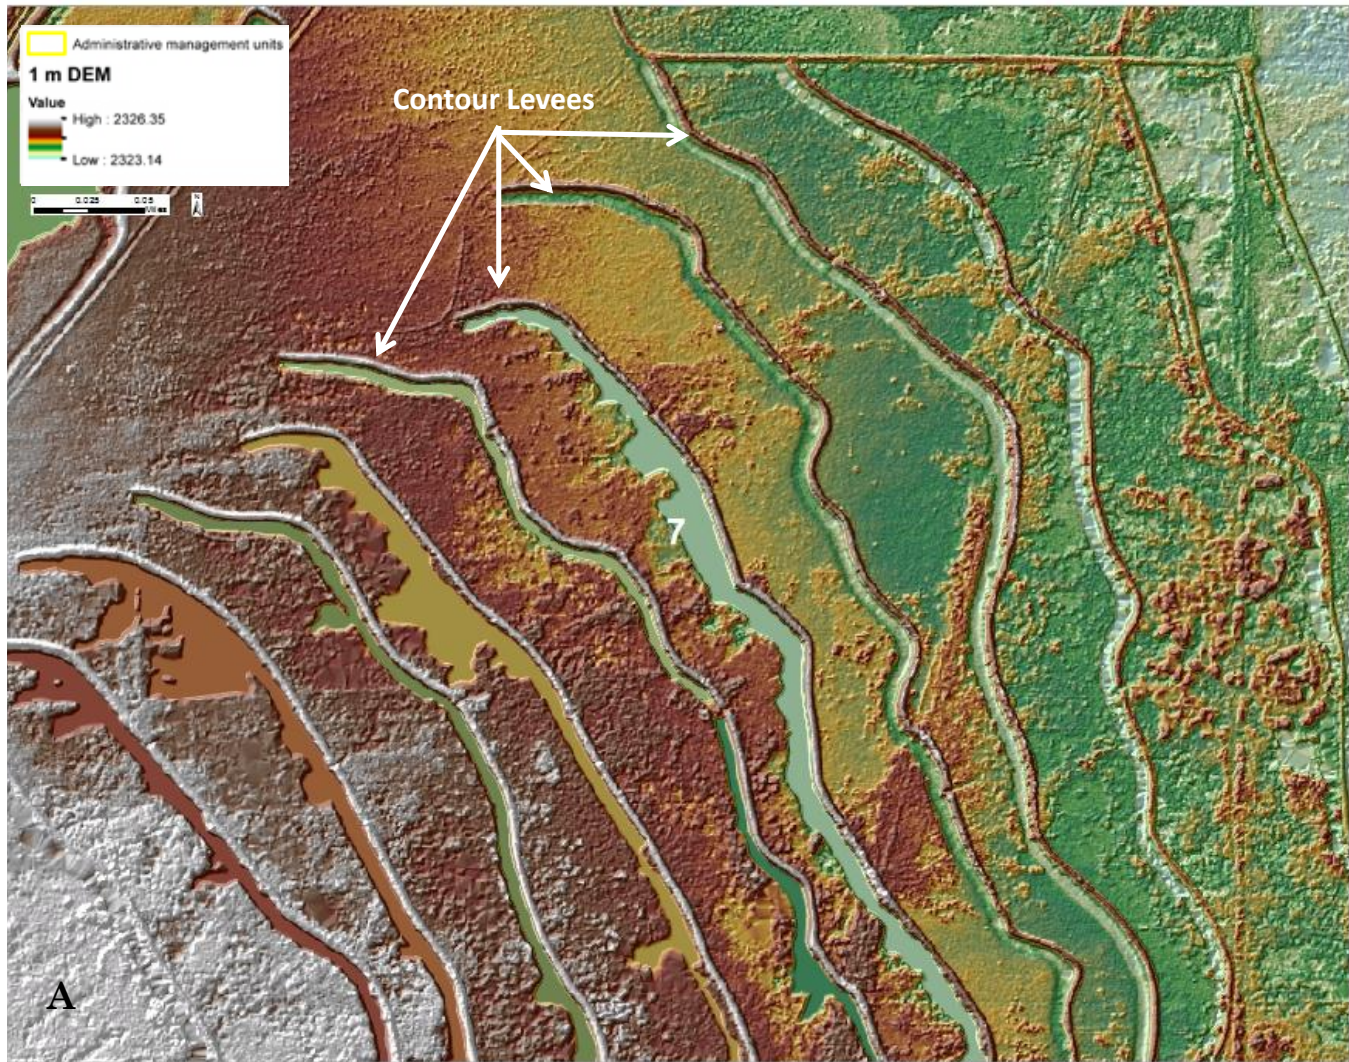
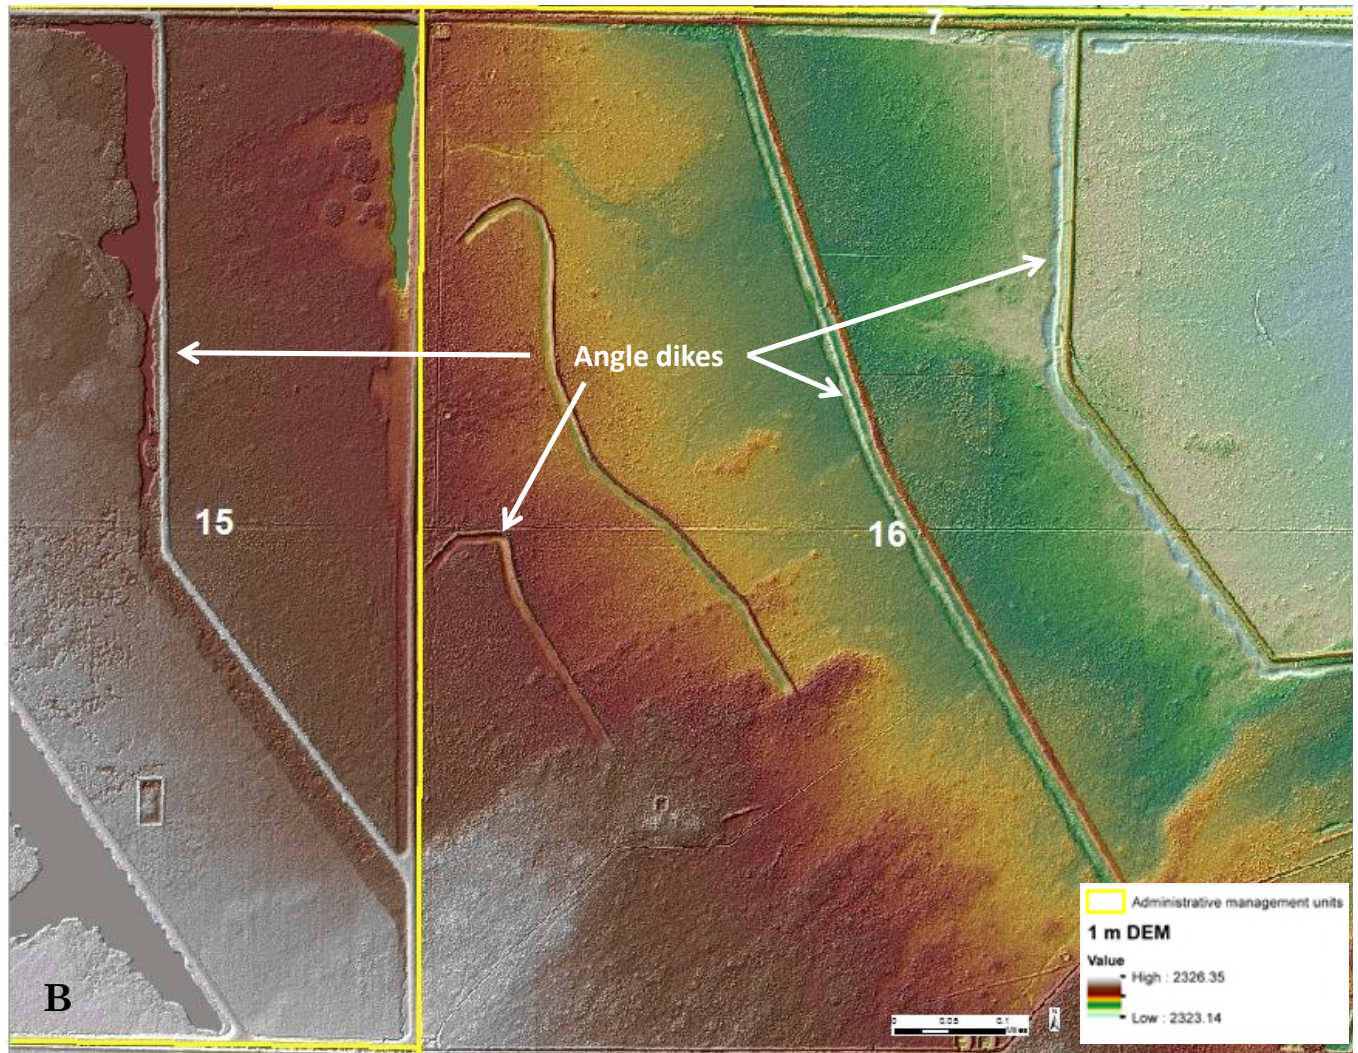
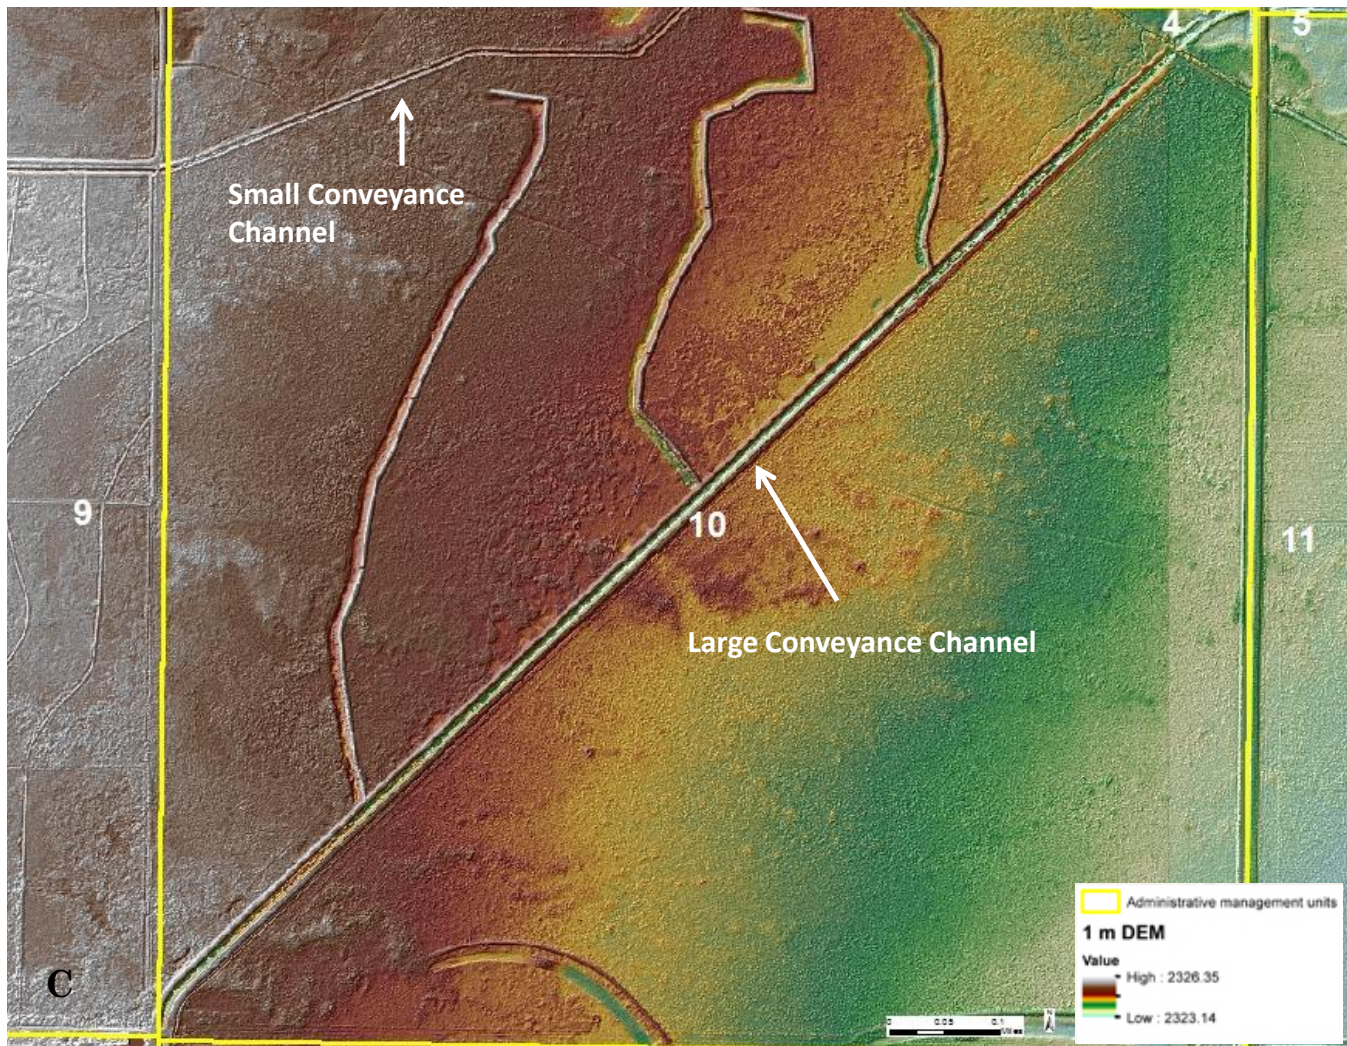
Figure 20. LiDAR DEM background showing: a) Unit 7, close-spaced contour levees, b) Units 15 and 16, angle-dikes, and c) Unit 10, conveyance channels on Monte Vista NWR.

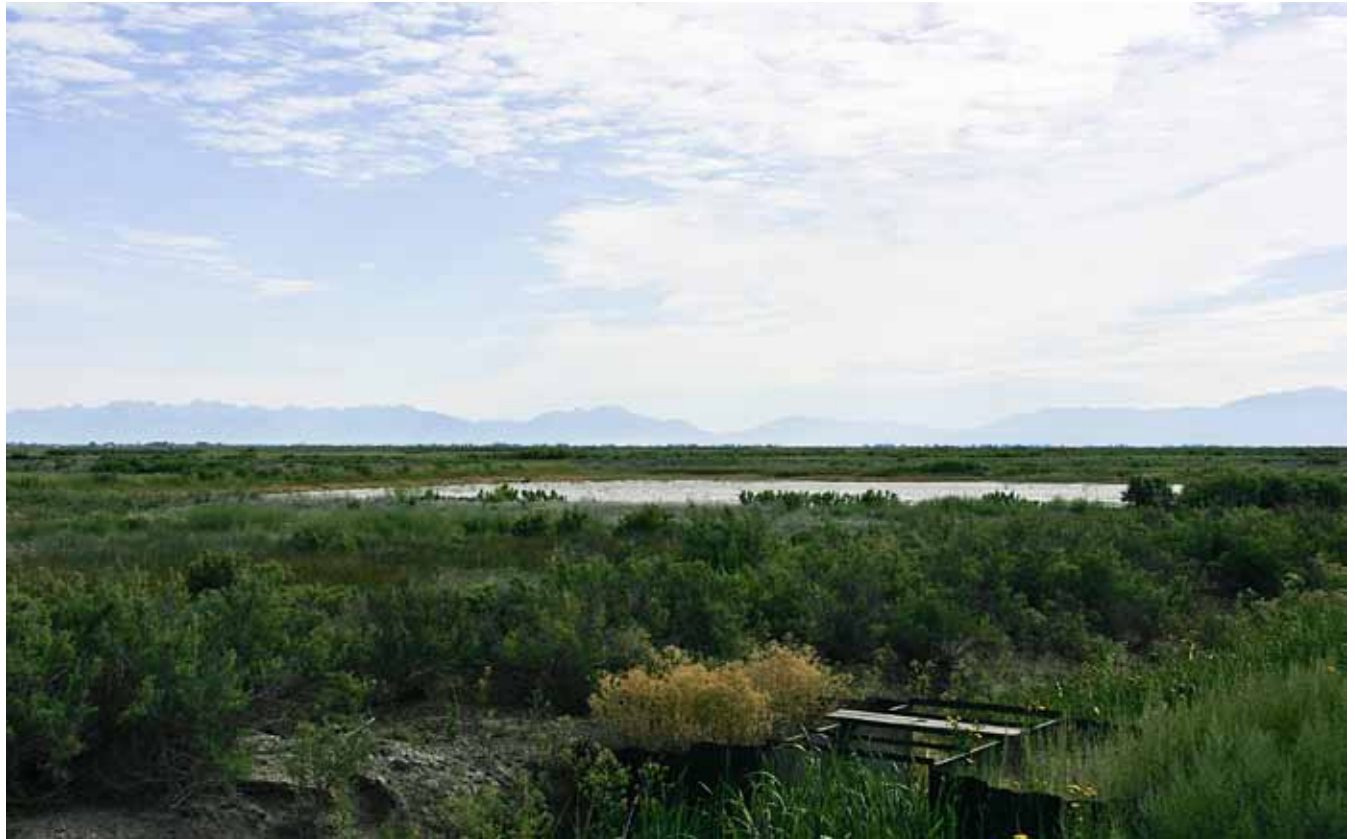
Figure 21. Photograph of a ring-dike around an artesian well on Monte Vista National Wildlife Refuge.
